ASBESTOS & LEAD BASED PAINT

TEST & SURVEY

517 GOLD SW

December 1994

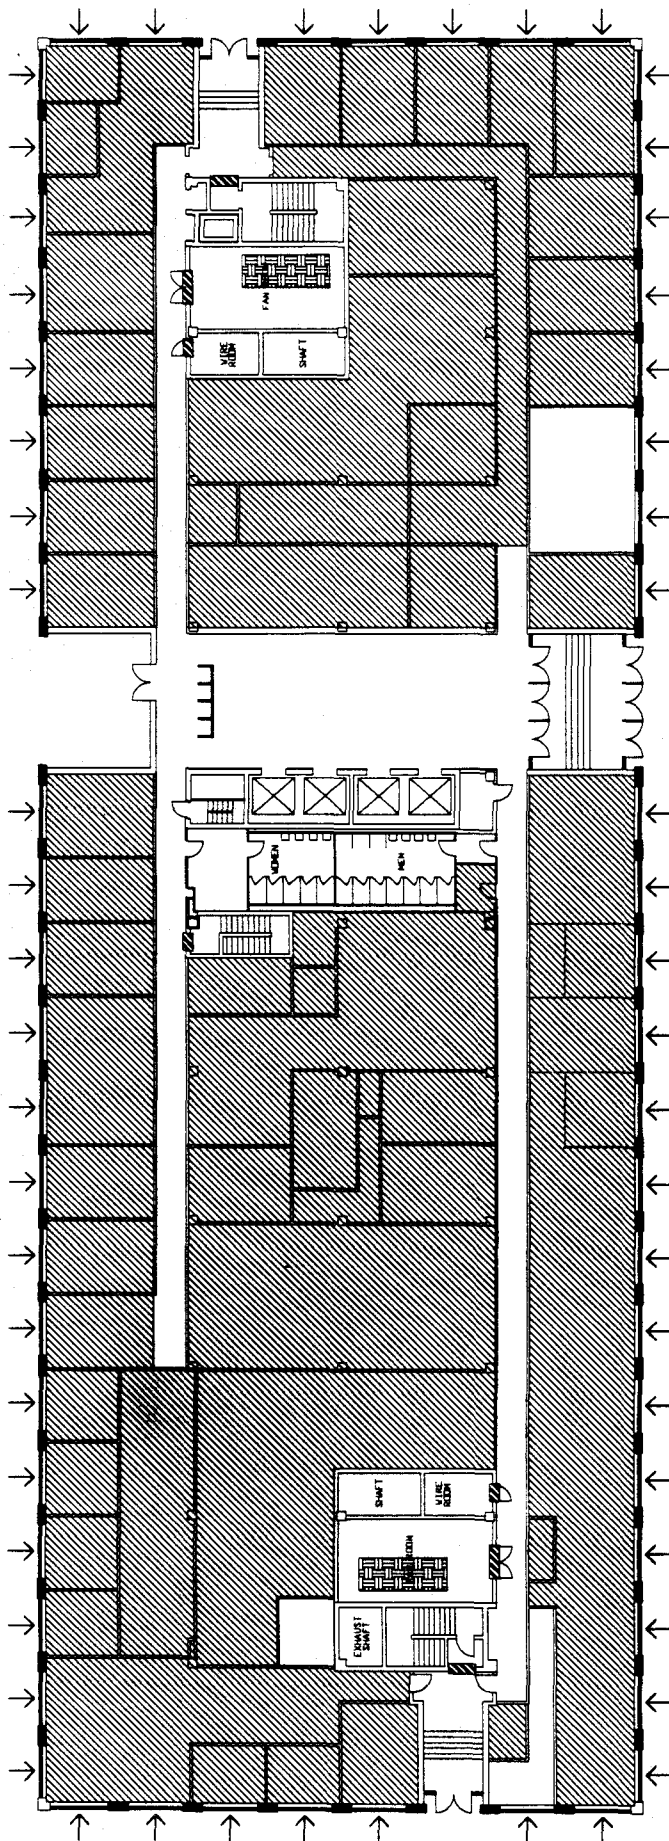
Z 517 GOLD S.W. FIRST FLOOR PLAN

- ▨ LOCATION OF ASBESTOS CONTAINING FLOOR TILE AND MASTIC
- ▨ LOCATION OF ASBESTOS CONTAINING FIRE DOORS
- ↑ LOCATION OF CEMENT ASBESTOS TRANSITE WINDOW PANELS
- ▨ LOCATION OF ASBESTOS CONTAINING MASTIC ON DUCT INSULATION
